## The vanishing threat: Stealthy malfunction of closed suction system

Cite: Das AK, Qureshi F, Kumar S, Kothari N. The vanishing threat: Stealthy malfunction of closed suction system. J Mech Vent 2023; 4(3):120-123.

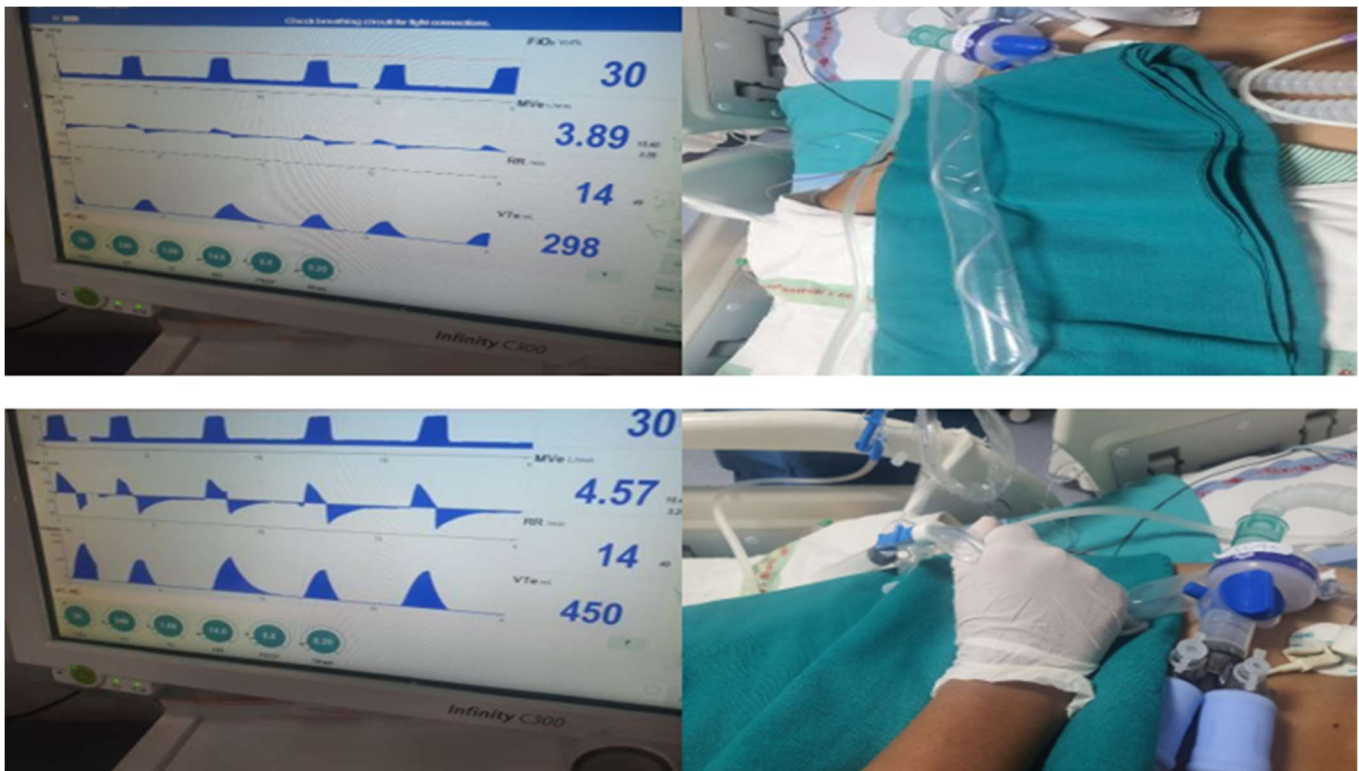
A bedside lung ultrasound showed an A profile with preserved lung sliding, and the chest radiograph showed no pneumothorax. Peak inspiratory pressures did not increase, and the position of the feeding tube was confirmed with a chest radiograph. The flow sensor of the mechanical ventilator was replaced with a new one, but despite all efforts, the leak persisted. It was observed that there was a rhythmic inflation and deflation of the polythene covering the closed suction system, synchronous with the respiratory cycle, which was causing the leak. Squeezing the polythene covering restored the VT, as shown in figure 1 and Table 1. The closed suction system was replaced with a new one, and the VT was restored, resulting in the resolution of the leak alarm.

Figure 1: The upper panel (top right) showing low tidal volume and inflation of close suction system synchronized with respiratory cycle (top left). The lower panel showing that the tidal volume was restored after squeezing the polythene.

In this case, the cause of the volume loss alarm was evaluated with an examination of the ventilator circuit for any damage, leak as well as endotracheal tube connections, cuff leak, etc. After all evaluations, the cause of volume loss was not found. There was alternative expansion and deflation of the polythene around the close suction system of the patient with the respiration of the patient. After squeezing the polythene of the closed suction system, the volume loss alarm disappeared. The volume leak problem

was solved by replacing it with a new closed suction system.
